## Coal Combustion Waste Impoundment

### Task 3- Dam Assessment Report

*John E. Amos Plant (Site 26)*

*Fly Ash Dam Complex  
American Electric Power  
St. Albans, West Virginia*

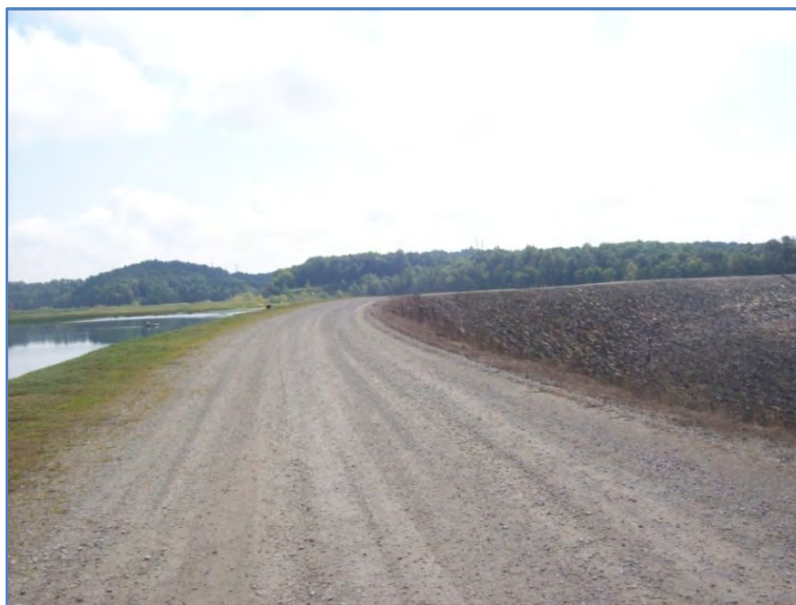
The dam crest had no signs of any depressions, tension cracks or other indications of settlement or shear failure, and appeared to be in satisfactory condition. Previous inspection reports reviewed by Dewberry indicated minor surface cracking in the clays on the upstream face. The cracking was described as "the result of desiccation". Photographs included with the reviewed report supported the desiccation description. The data did not indicate cracking along the crest or downstream face of the dam. Figure 5.2.1-1 shows the conditions of the dam crest.

Figure 5.2.1-1. Photo Showing the Dam Crest.

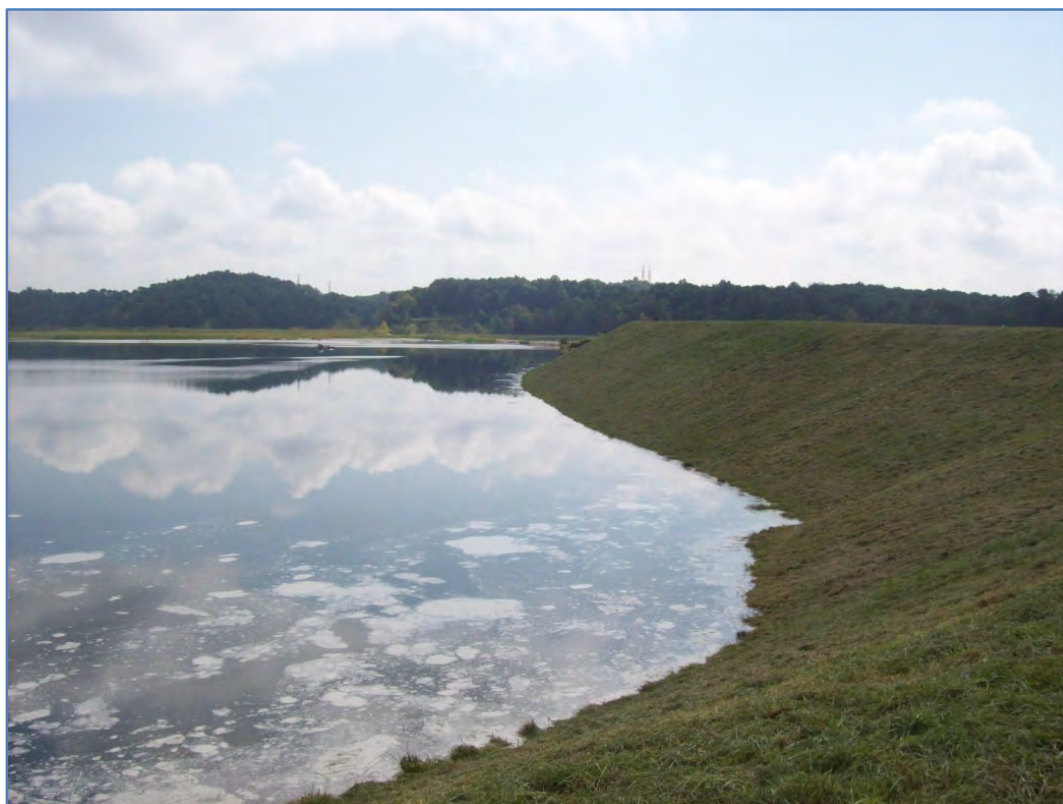
The upstream slope is protected with grass. There were no observed scarps, sloughs, bulging, cracks or scraps or depressions or other indications of slope instability or signs of erosion. Figures 15 and 16 in Appendix B show the upstream slope. Figure 5.2.2-1 depicts part of the upstream slope of the dam embankment.

Figure 5.2.2-1. Photo Showing the Upstream Slope.

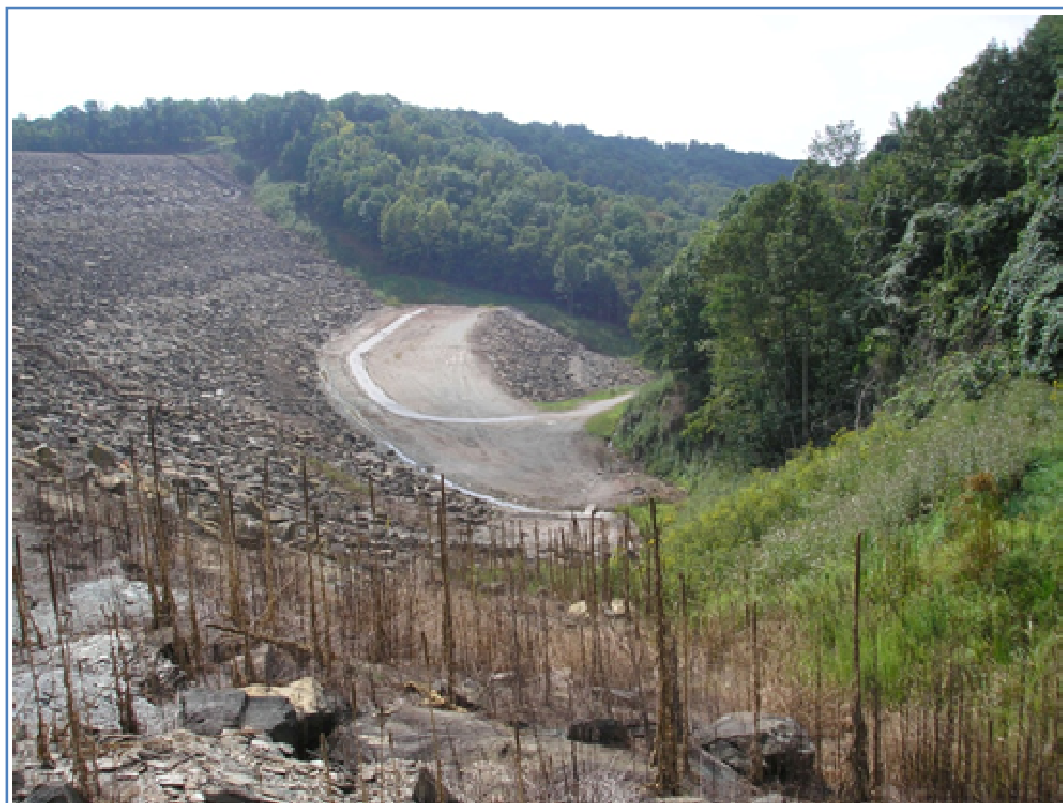
The downstream slope of the entire dam is covered with large rock boulders (rip-rap). Also, the downstream slope has a bench that has a sloped surface with the elevation carrying from 713 ft to 716 ft (referred to as "716 Bench" in some dam documents). There were no observed scarps, sloughs, depressions or other indications of slope instability or signs of erosion or uncontrolled seepage. Isolated locations of weathered rip-rap on downstream face were observed. Seepage was observed from underdrains as well as isolated points on the embankment slope. The seepage on the embankment slope was believed to be due to percolation of local runoff from the dam bench and not from the water stored in the reservoir. This was evident from the local drainage rill disappearing up gradient from the seepage spot. No seepage was observed over a widespread area or the downstream foundation area and there was no water against the downstream toe. Figures 1-3, 5-7, 10 and 17-19 in Appendix B depict various views of the downstream slope. Figure 5.2.3-1 shows the downstream slope from North Abutment of the dam.

Figure 5.2.3-1. Downstream Slope from North Abutment,

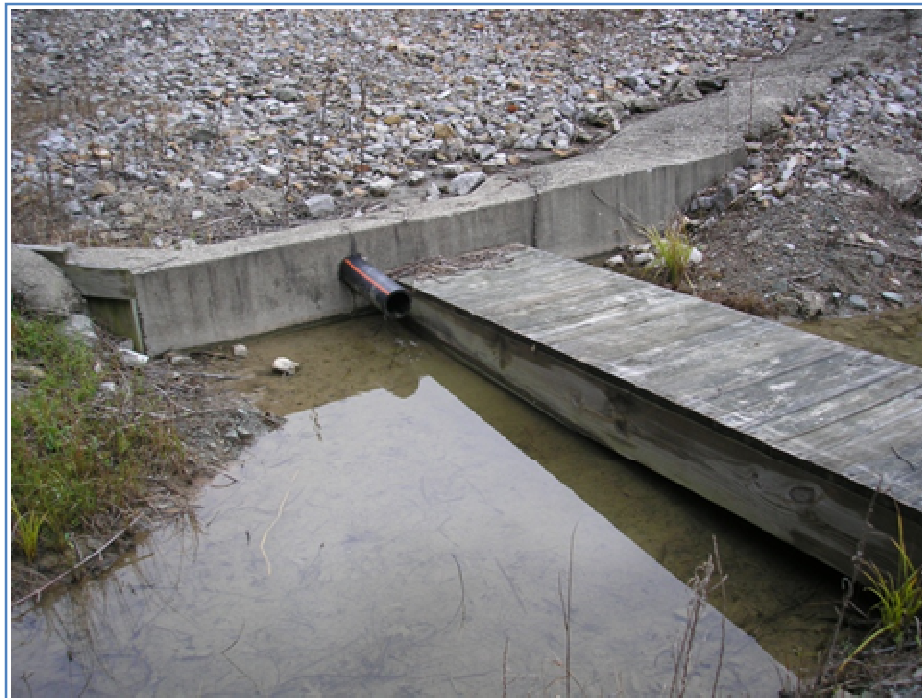
Figure 5.2.3-2 shows the Seepage Collection Basin in the downstream embankment toe receiving seepage water from a drain pipe.

Figure 5.2.3-2. Seepage Collection Basin, Downstream Embankment.

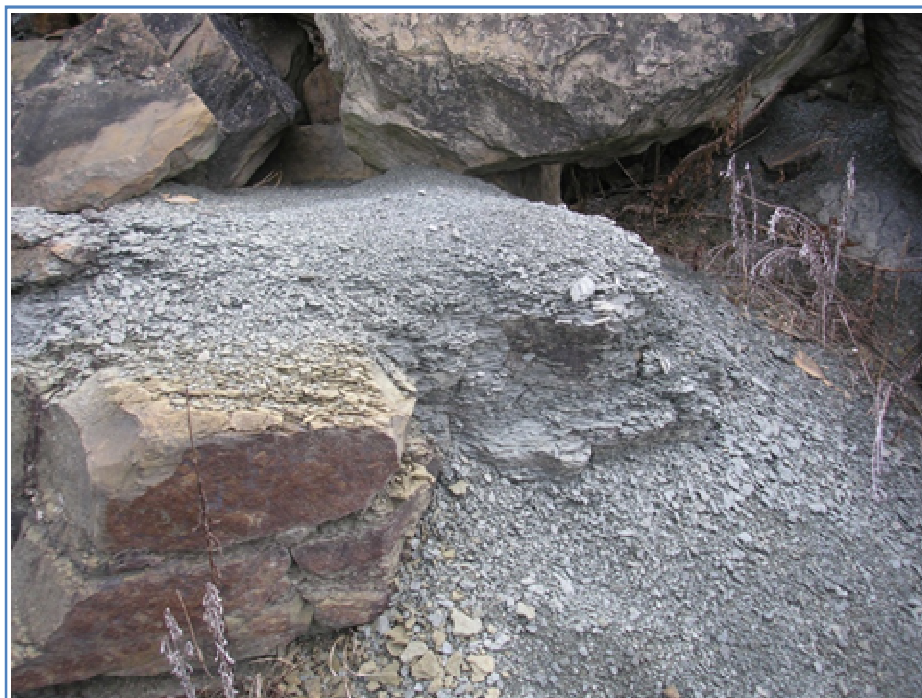
The photographs included in the WV- Dam report indicated deterioration was limited to moderate to severe weathering of approximately 10 percent of the sandstone and shale rip-rap on the downstream face of the dam. Weathering is reported to be most apparent below the bench at approximately Elevation 716 ft in the downstream slope. During the 9/8/09 dam inspection, Dewberry personnel observed weathered rip-rap on isolated spots on the downstream slope (see Figure 5.2.3-3).

Figure 5.2.3-3. Weathered Rip-Rap at Downstream Slope.

- Evaluate valve condition at the overflow structure to assure it is operational in case flow out of the pond needs to be stopped;
- Monitor, address or otherwise repair minor erosion areas and erosion gullies, wet areas and isolated seepage spots.

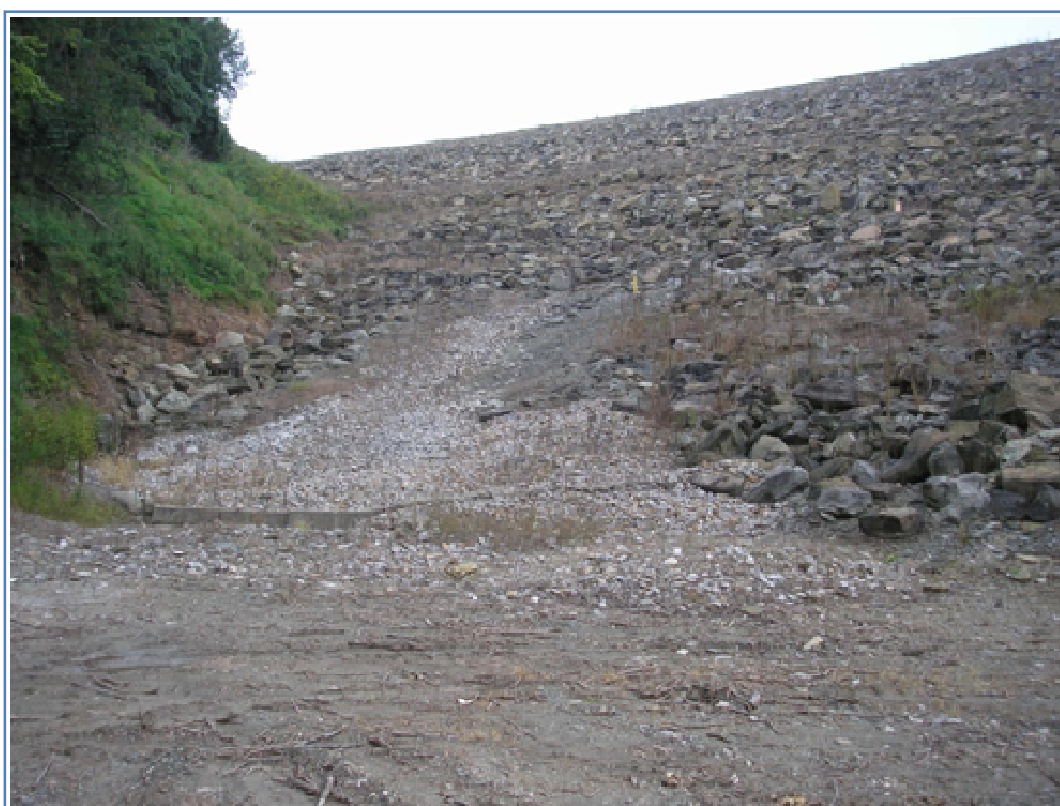
Erosion or uncontrolled seepage was not observed along either groin. The abutments and groin areas appeared to be in excellent condition. The groin slopes are protected with rip-rap. Figure 5.2.4-1 shows the Abutment/Groin at the "716 Bench".

Figure 5.2.4-1. Downstream North Abutment/Groin at "716 Bench".

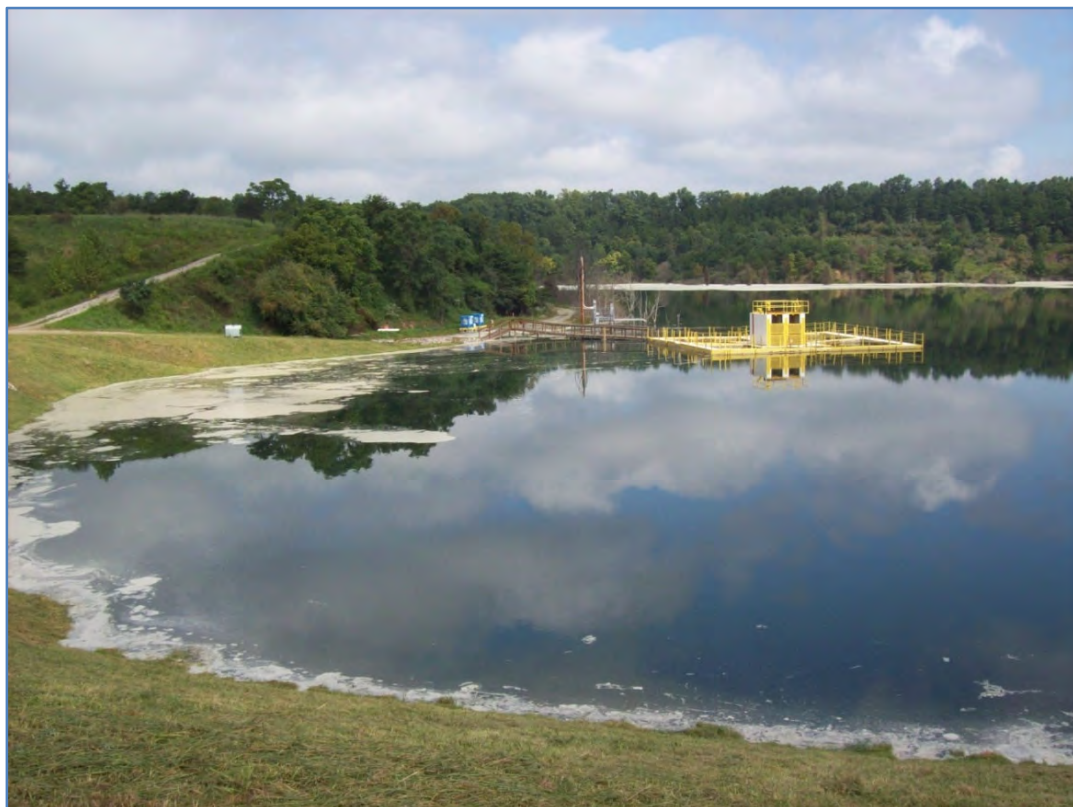
The primary overflow structure was observed to be working properly, discharging flow from the pond, and visually appeared to be in satisfactory condition. There was no sign of clogging of the spillway and the water exiting the outlet was flowing clear. Figure 5.3.1-1 shows the main outlet structure and the floating pier around it within the reservoir.

Figure 5.3.1-1. Outlet Structure (Principal Spillway) and the Floating Pier Around it on the Northwest End of Dam.

- Repair access stairs and walkways to monitoring points if the dam is not expanded;
- Evaluate the cause of movement restrictions of floating docks around the decant riser and repair wooden walkway to overflow structure;

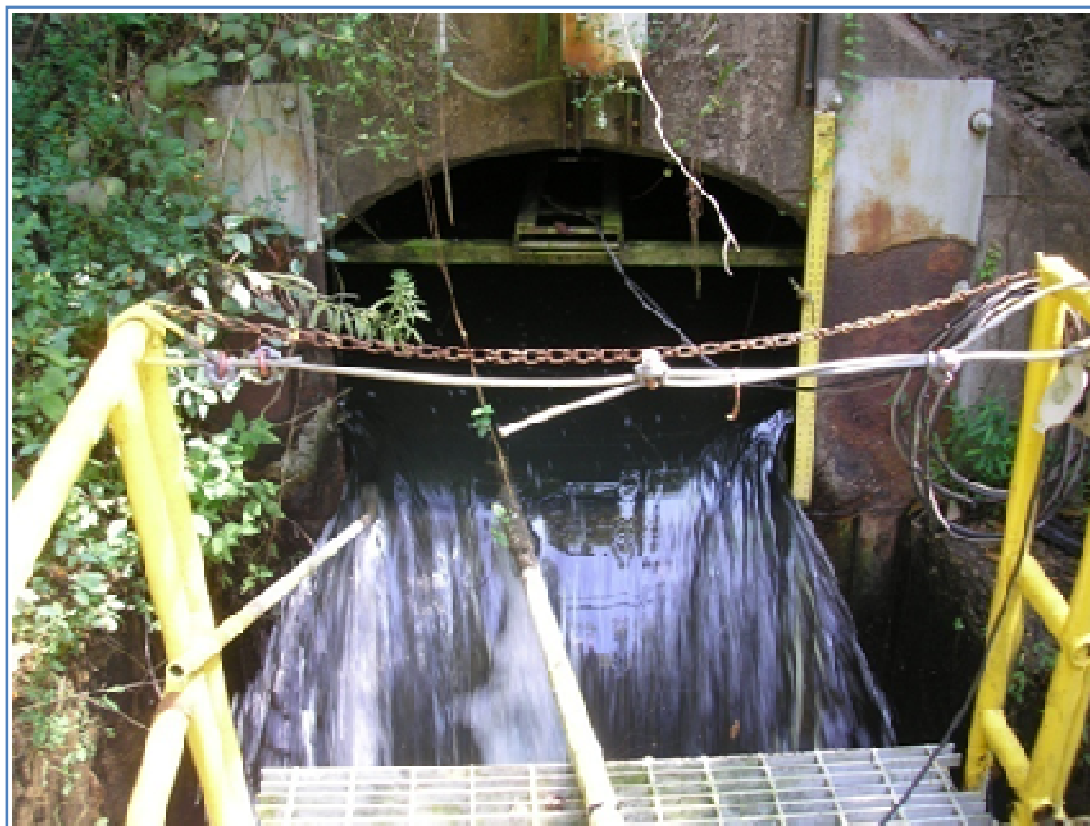
The outlet conduit appeared to be in good shape and operating normally with no sign of clogging and the water exiting the outlet was flowing clear. Figure 5.3.2-1 shows the water discharging from the main spillway tunnel outfall.

Figure 5.3.2-1. Main Spillway Tunnel Outfall.

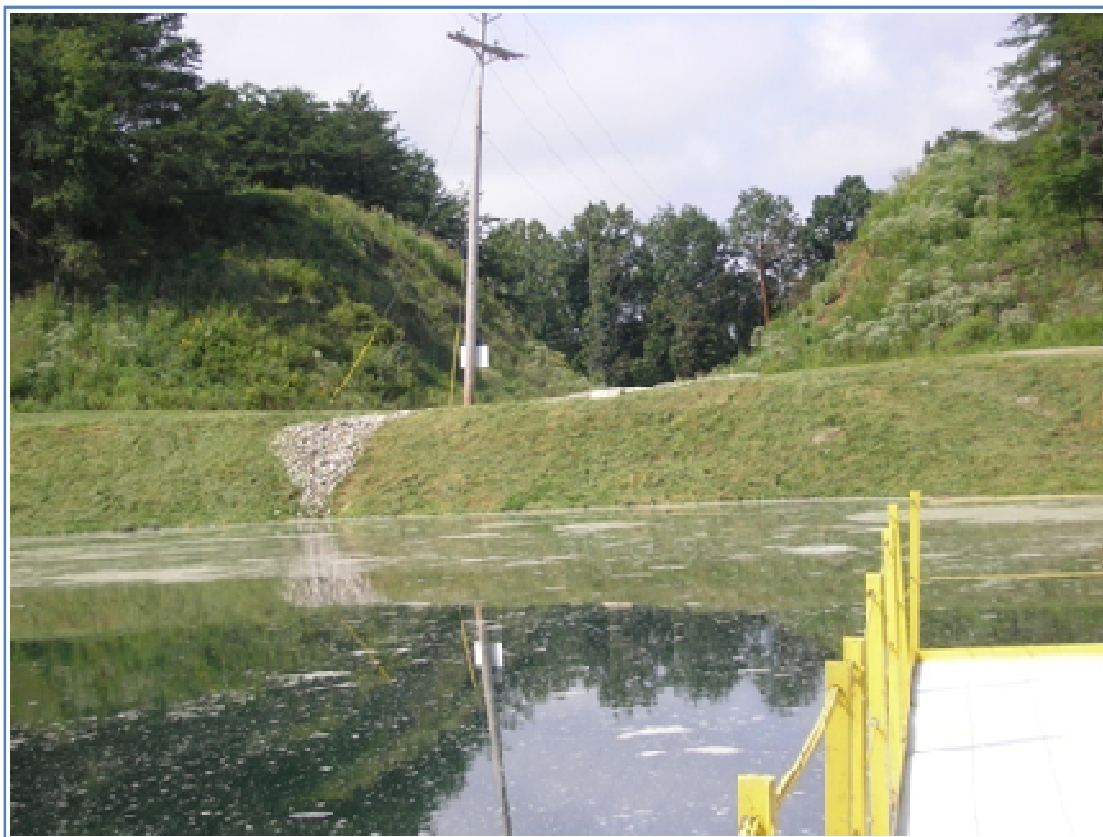
The emergency spillway appeared to be in good condition with no sign of clogging.

Figure 5.3.3-1. Emergency Spillway at the North end of Dam.
